CFB Petawawa Military Base Upgrades Outfall

Project: Canadian Forces Base Petawawa

Product: Stormceptor® STC 14000

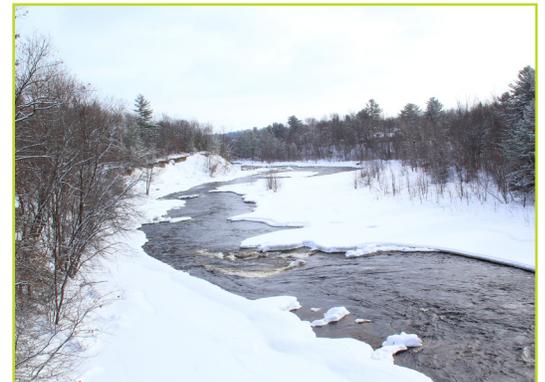
Analysis of the pre-existing storm sewer immediately upstream of Outfall #1 indicated that the majority of the system was undersized for both the 2 and 5 year events, and flow velocities exceeded the typical recommended design velocity. This was a concern with the existing infrastructure, which included a Stormceptor (designed and installed nearly 20 years ago). As development continued on the Base over the years it was found that the resulting storm sewer hydraulic changes began to limit the existing sewer's capacity and unit's overall functionality.

Additionally, to address additional downstream erosion issues in the creek the alignment of the Outfall #1 sewer pipe's outlet required adjustment so it would be more in line with the creek's flow, rather than perpendicular to it.

- An additional Stormceptor STC 14000 with only 75mm (3-inches) of required drop from inlet to outlet was added. This improved the overall long-term TSS removal, and provided additional hydrocarbon spill protection & capacity.
- Storm sewer pipe sizes were increased, to reduce the sewer system's flow velocities and increase the discharge capacity.
- The Outfall #1 was realigned and rip-rap stone protection was added to mitigate the erosion downstream.
